***ENERGY STAR Qualified Homes  
Infrared Camera  
Evaluation***

# ENERGY STAR QUALIFIED HOMES IR CAMERA EVALUATION FOUR CITY STUDY

- ***Columbus, OH***
- ***Salt Lake City, UT***
- ***El Paso, TX***
- ***Minneapolis, MN***

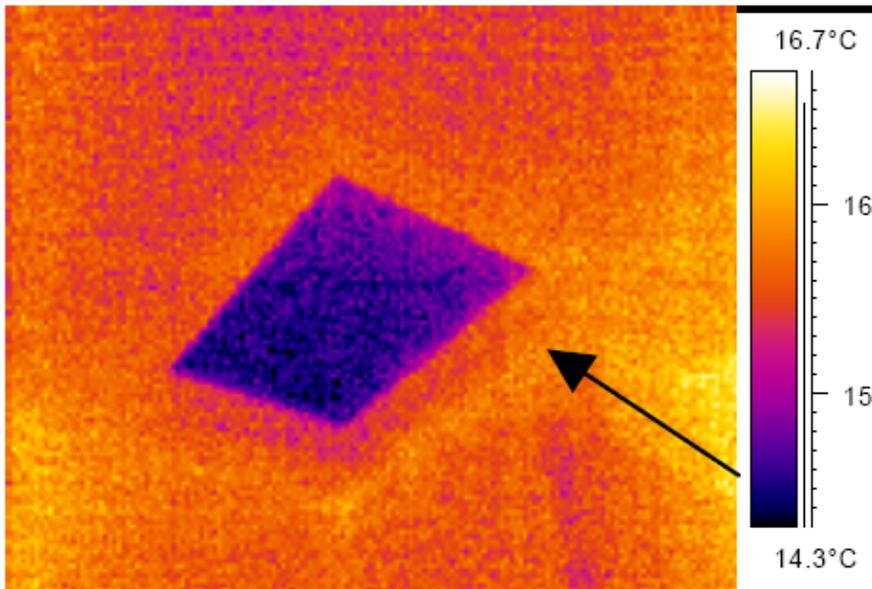
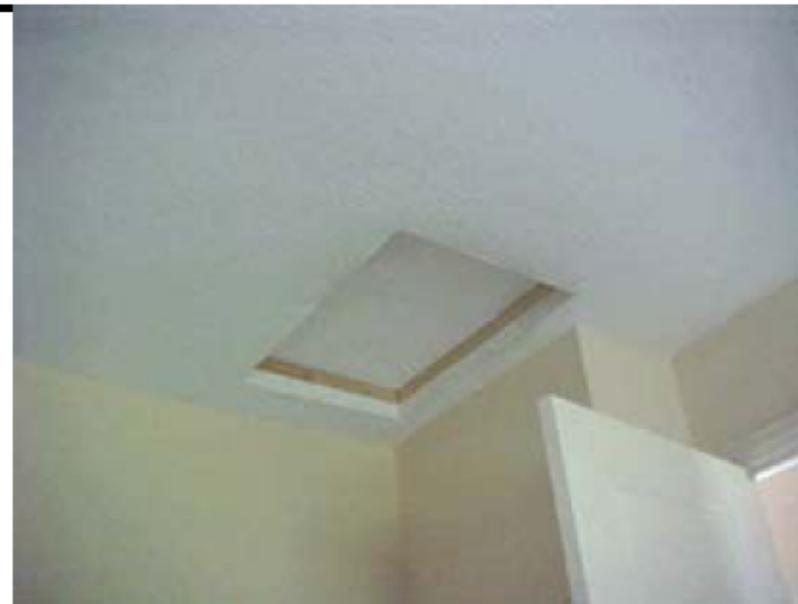
Attic access panel, IR-5, showing either no or improperly installed  
3. (not attached directly to panel cover) insulation on back side

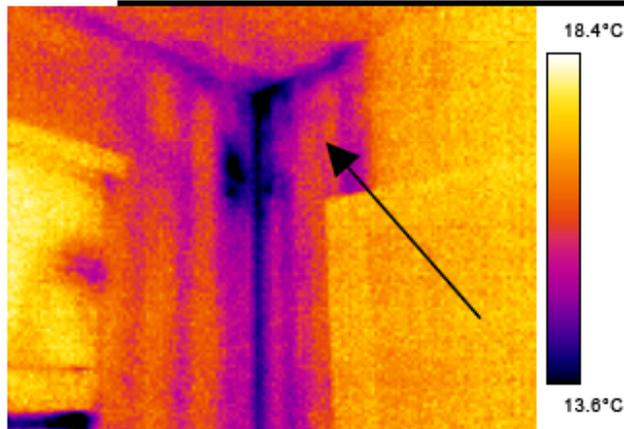
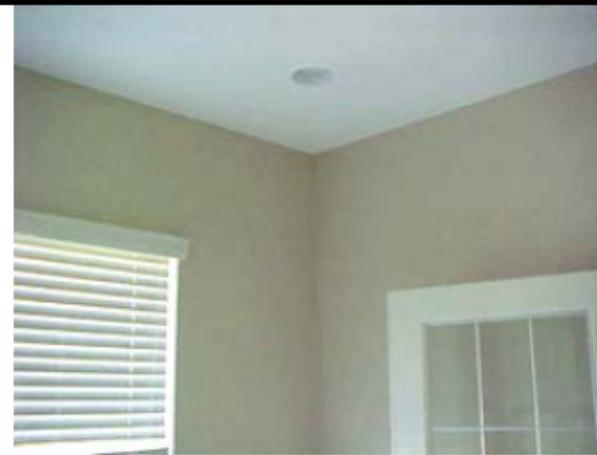
## 1. Dining room upper NE corner showing air infiltration IR-14

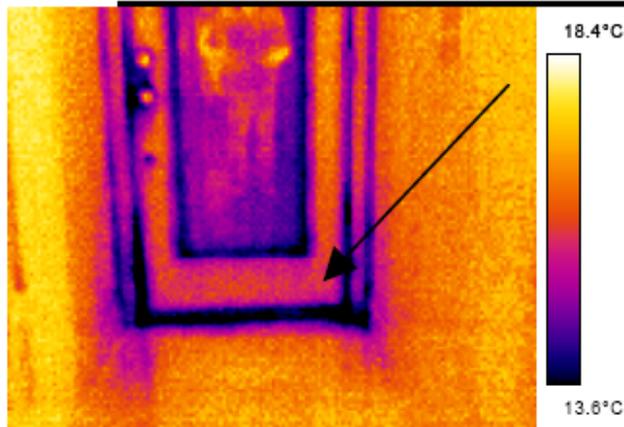
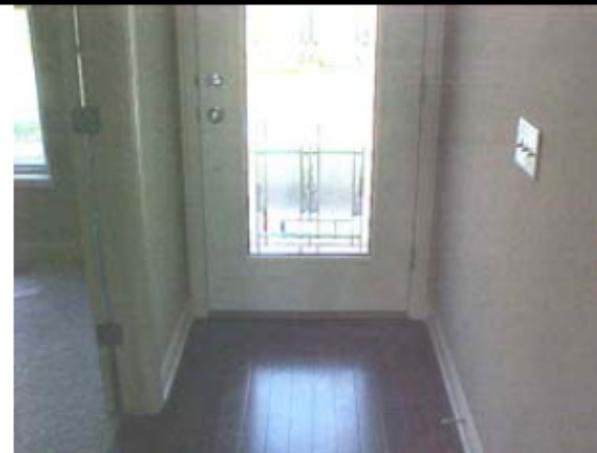
## 2. Front door air infiltration (weather-strip installed) IR-15

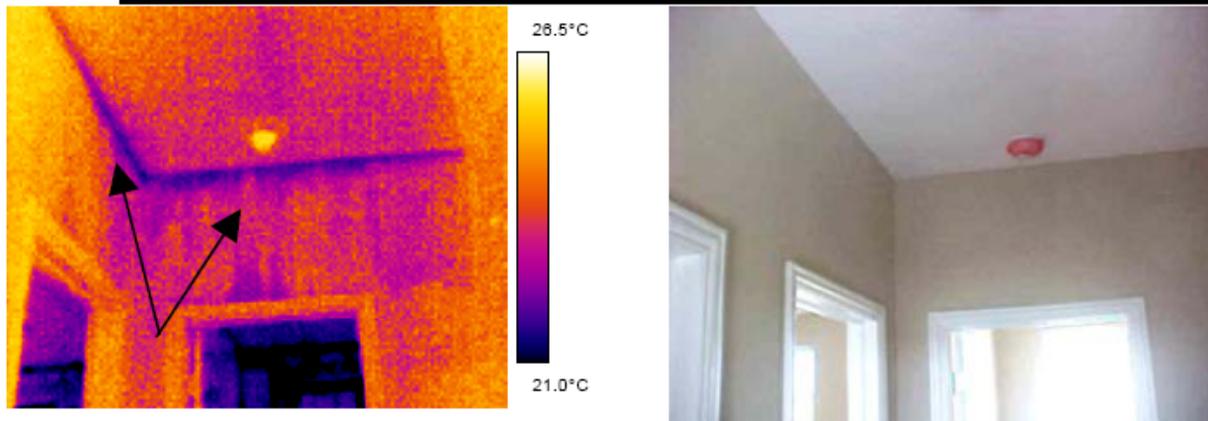
Upstairs hall interior walls showing air infiltration from attic along  
**5. top of wall IR-23**

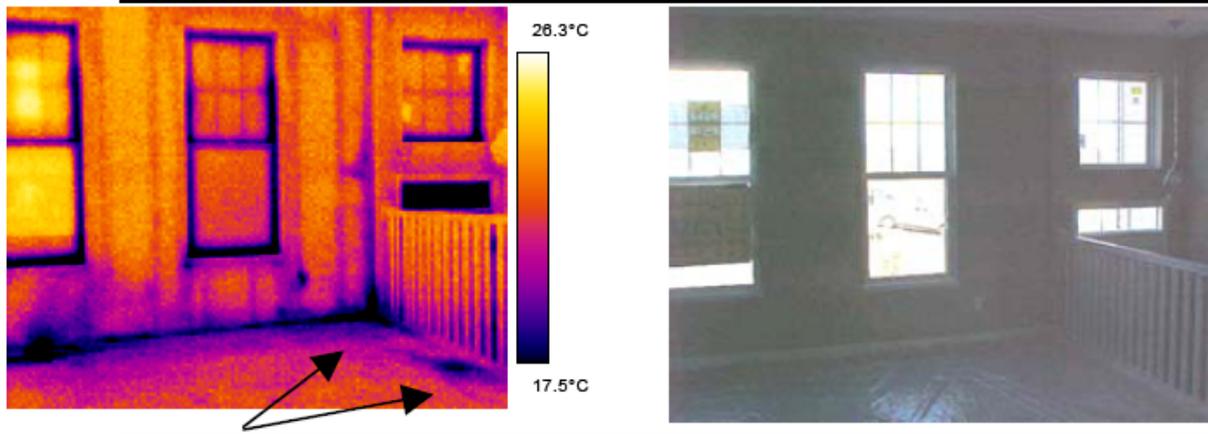
North wall front room first floor showing air infiltration along base  
**6. of floor and in floor cavity which is above garage IR-24**

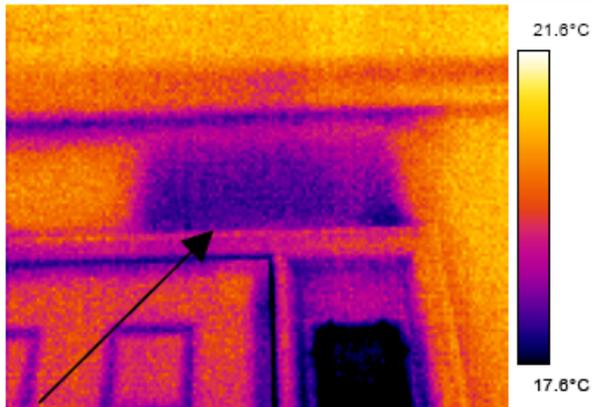
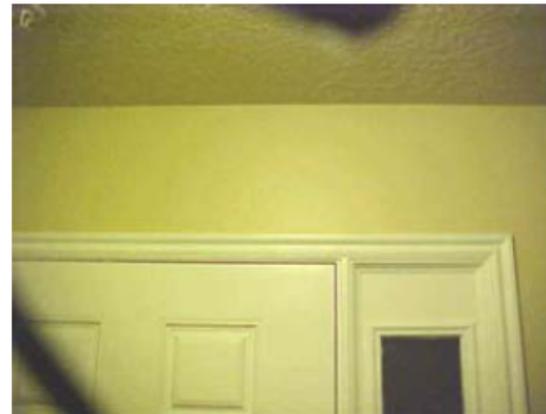
## 1. Above front door showing missing insulation IR-1

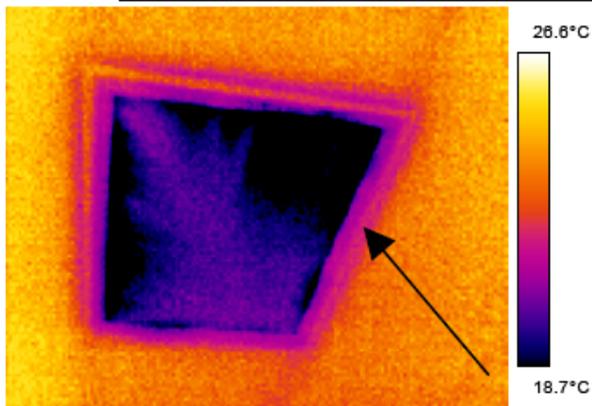
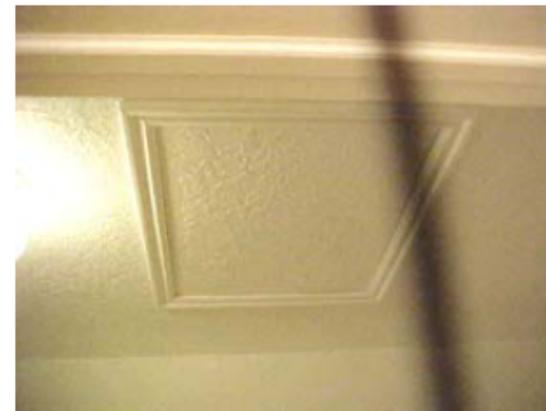
Attic access panel in master closet, IR-2, showing either no or improperly installed (not attached directly to panel cover)

## 2. insulation on back side

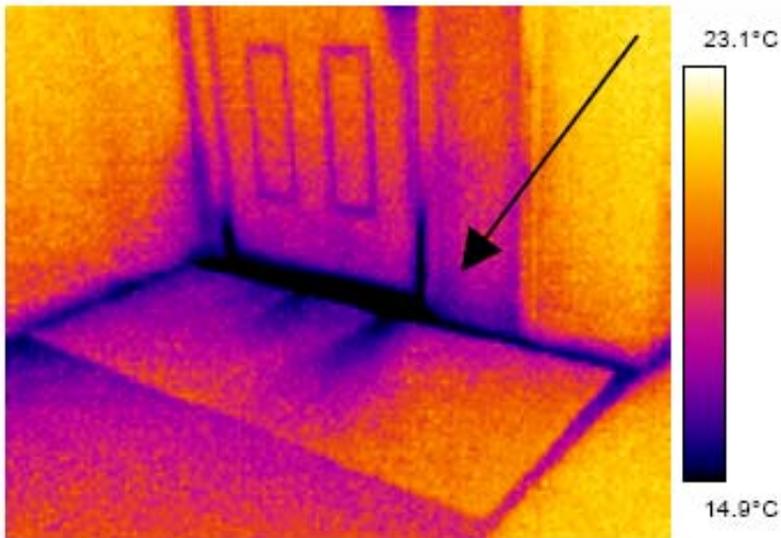
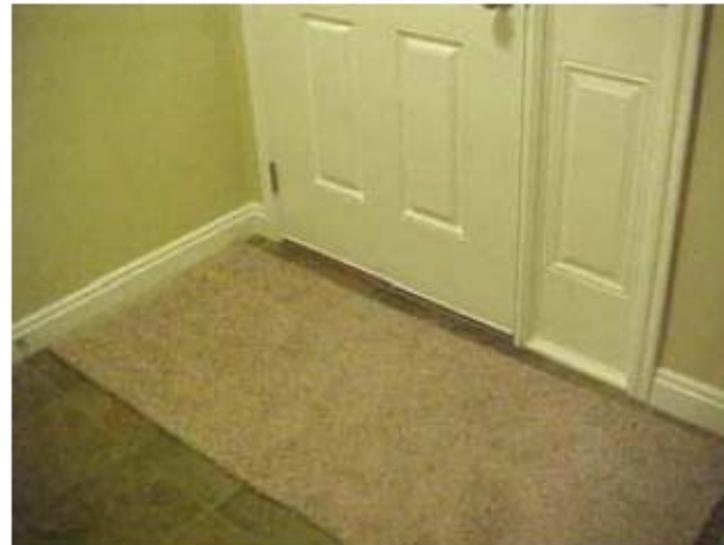
## 1. Base of front door showing air infiltration IR-3

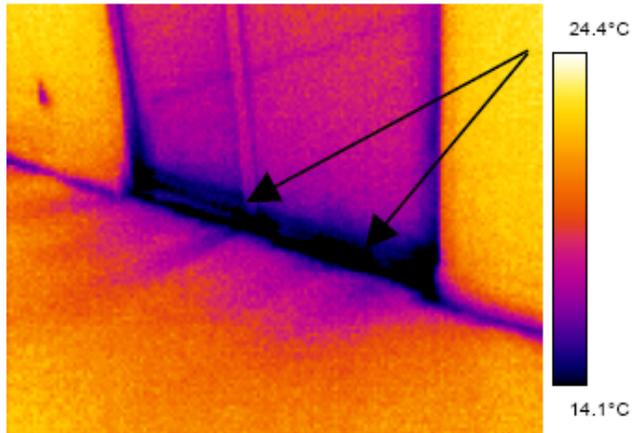
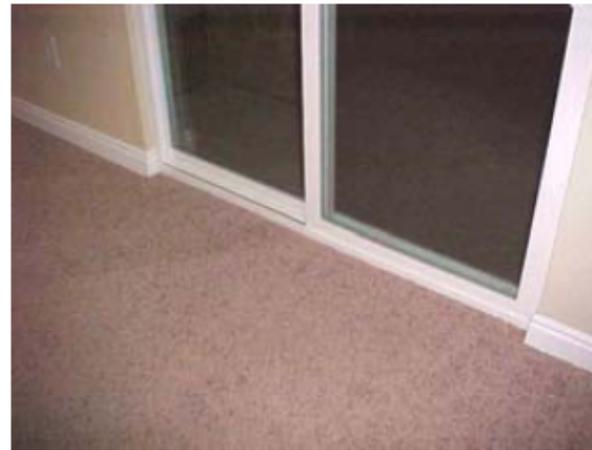
## 2. Base of patio sliding door showing air infiltration IR-4

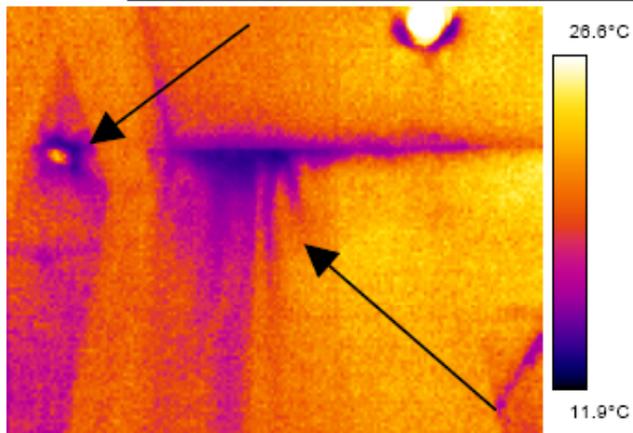
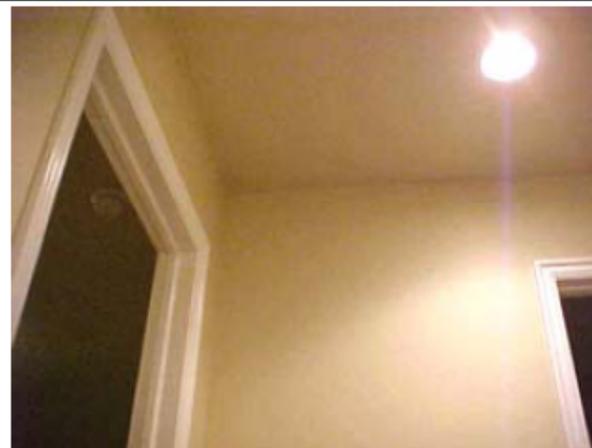
## 3. Interior wall at top of stairs and smoke detector master bedroom showing air infiltration IR-5

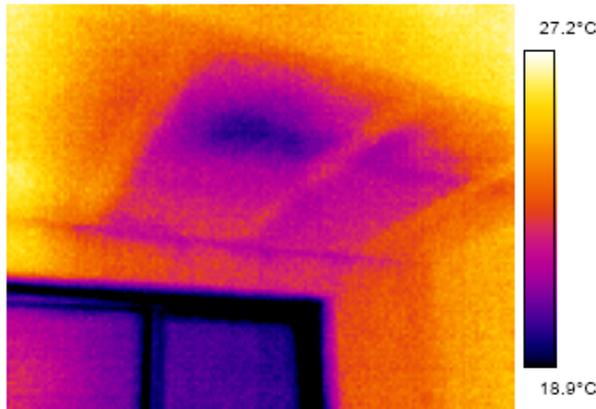
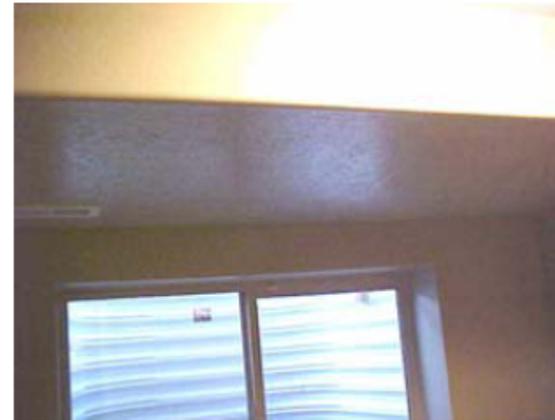
Bulkhead type ceiling in basement bedroom below study showing  
2. air infiltration IR-20

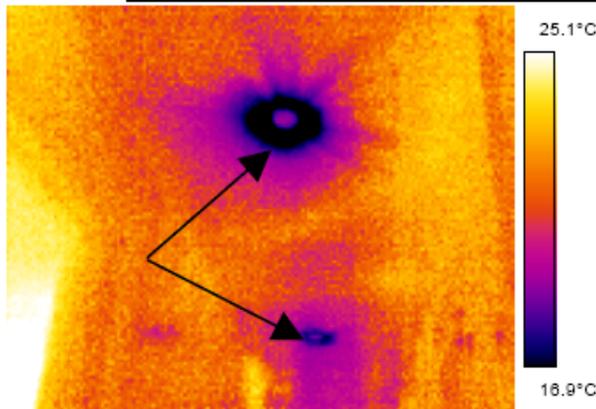
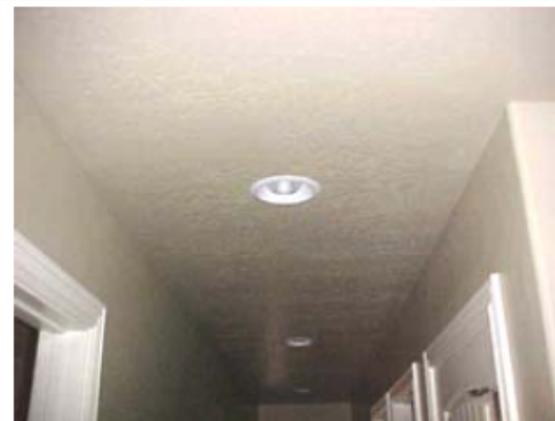
Upstairs hall can lights-typical throughout showing air infiltration  
3. IR-21

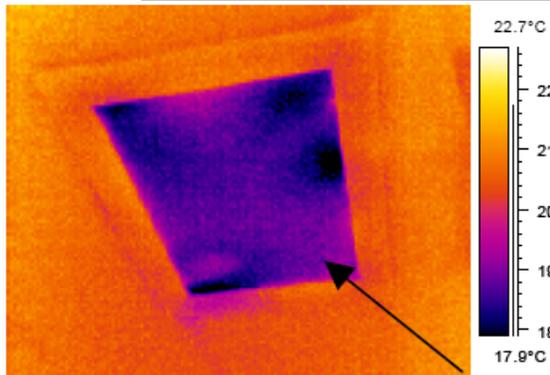
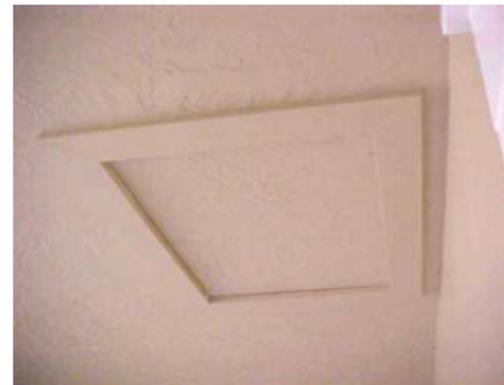
Attic access panel in ceiling west bedroom IR-25, showing either no or improperly installed (not attached directly to panel cover)

## 1. insulation on back side

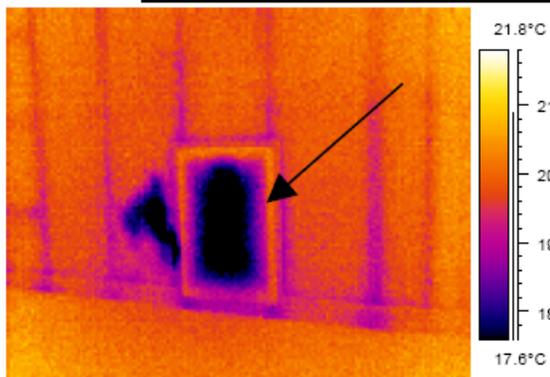
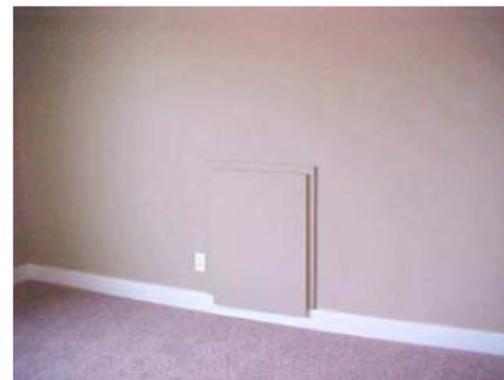
North wall attic access panel and adjacent cavity in west bedroom IR-26, showing either no or improperly installed (not attached directly to panel cover)

## 2. directly to panel cover) insulation on back side

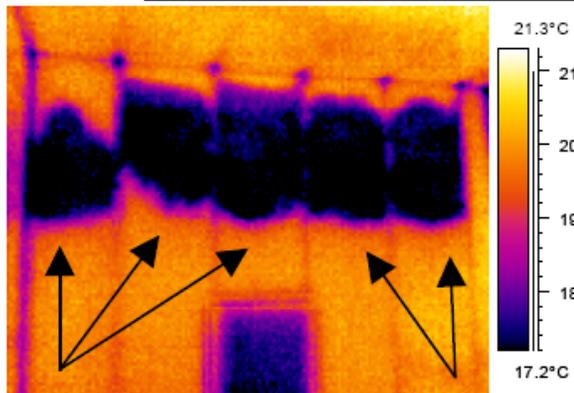
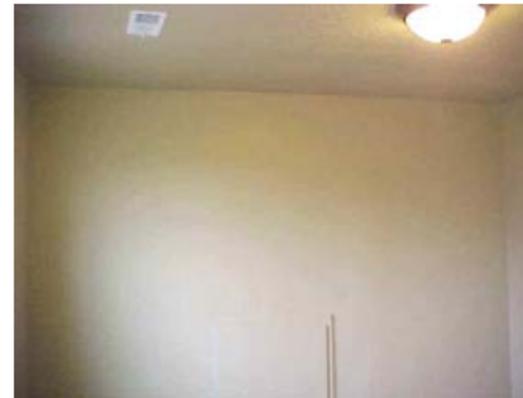
South wall insulation voids in cavities above attic access east  
4. bedroom (entire length of wall IR28)

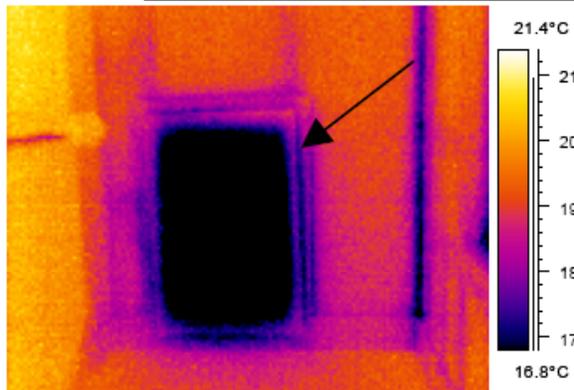
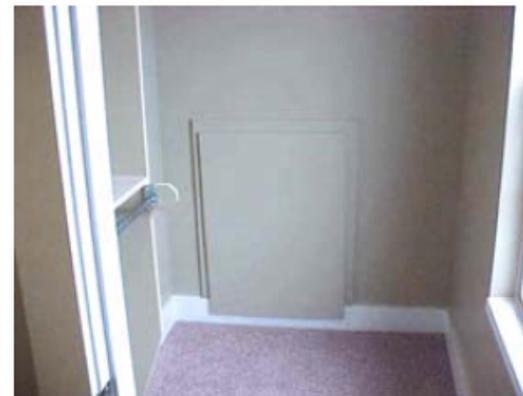
North wall attic access panel in east bedroom closet IR-29,  
showing either no or improperly installed (not attached directly to  
5. panel cover) insulation on back side

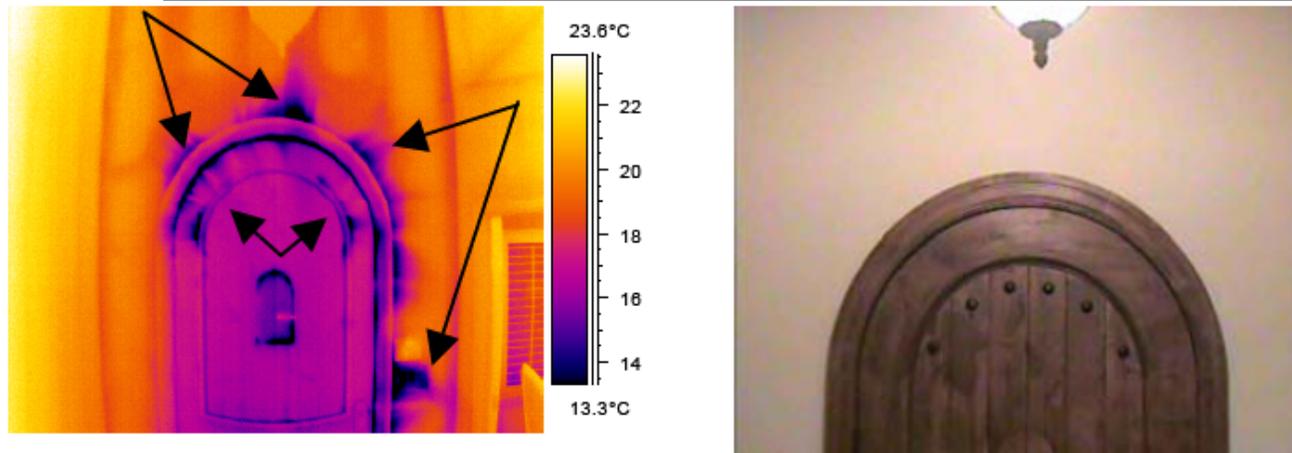
## 1. IR13 Front exterior door showing areas of air infiltration

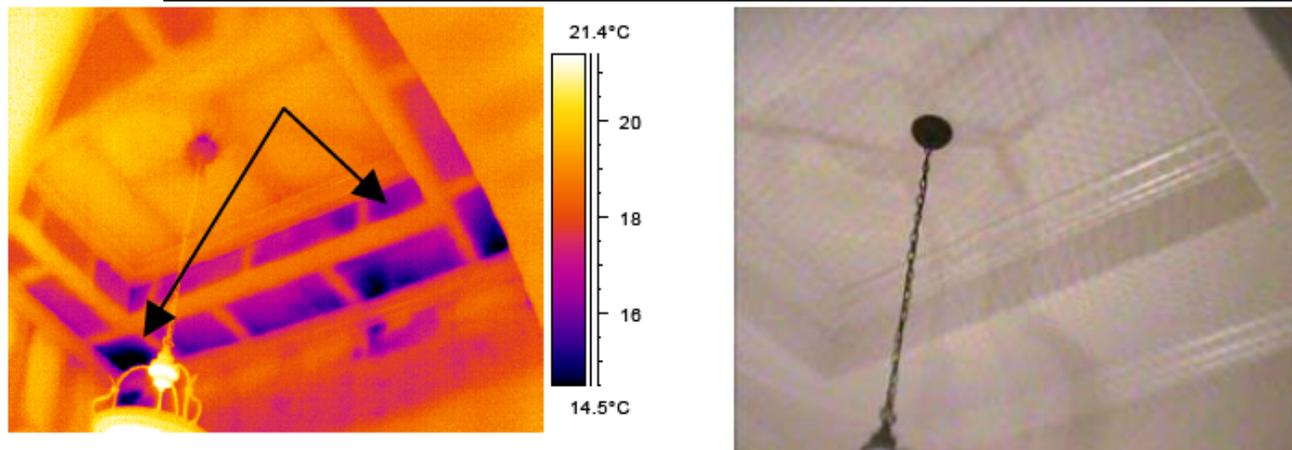
## 2. IR15 Front entry ceiling bulkheads showing air infiltration throughout

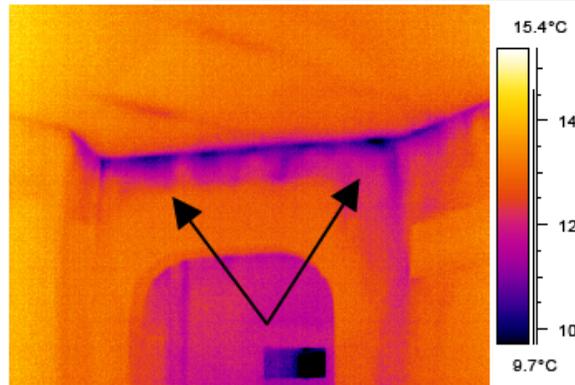
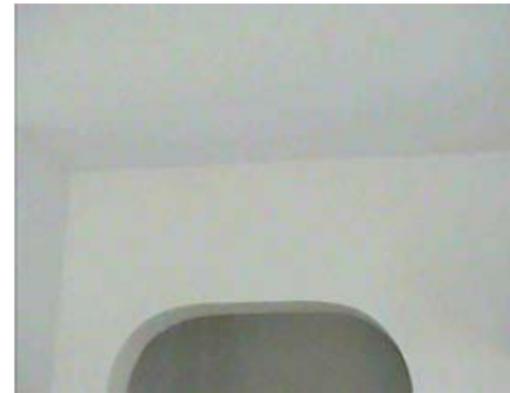
IR29 Top of wall between master bedroom and bath showing air  
1. infiltration within wall cavity

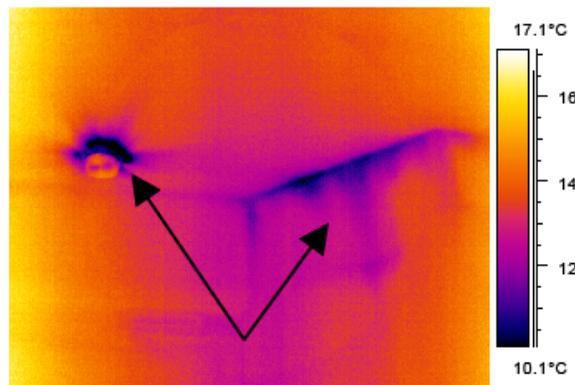
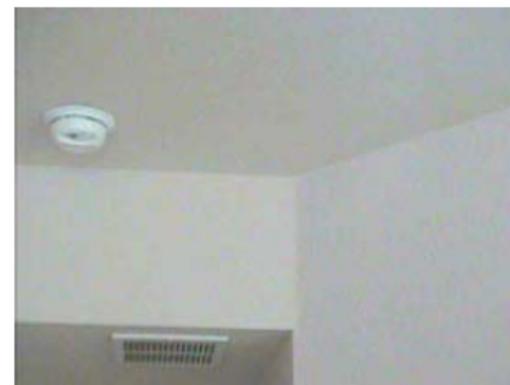
IR31 Master bedroom entry looking at smoke detector and top of  
2. wall to right showing air infiltration to the interior from detector  
and within wall cavity

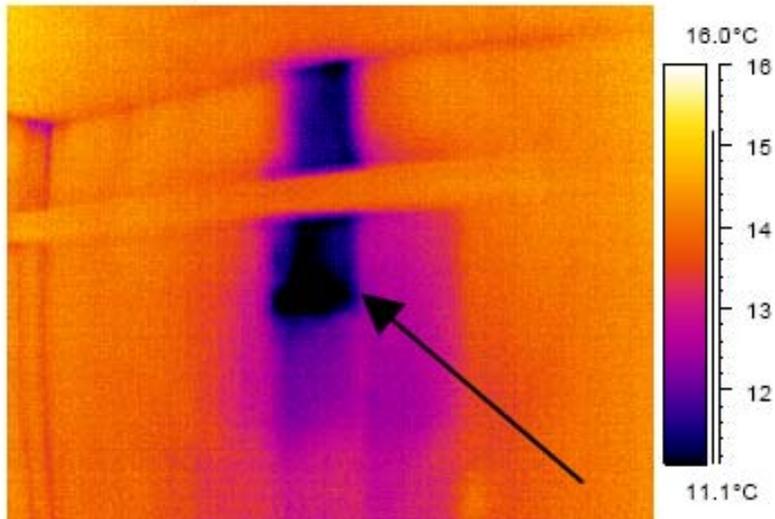
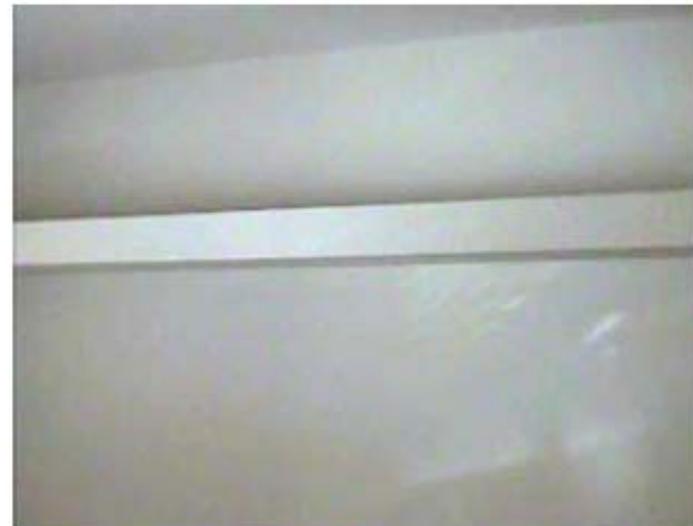
IR35 South bedroom wall common with kitchen exhaust showing  
1. open to attic

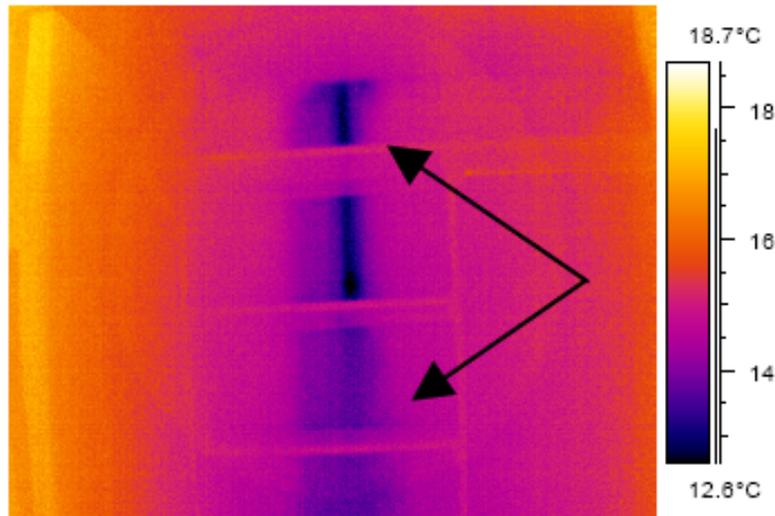
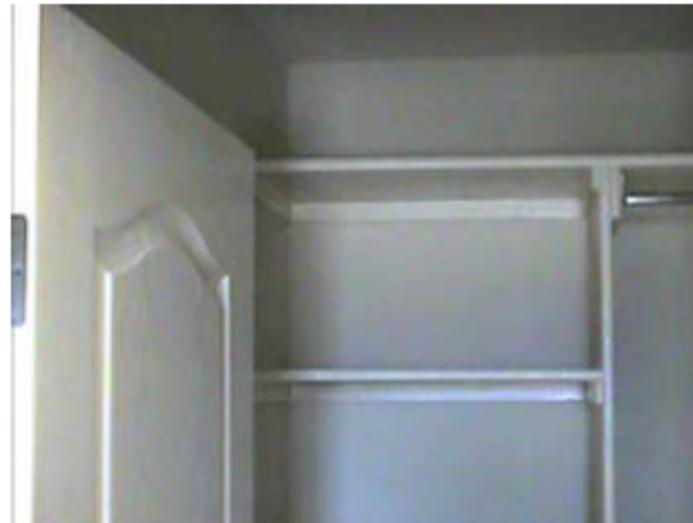
IR49 Maser closet back wall common with dryer vent showing air  
**4. infiltration within the wall cavity**

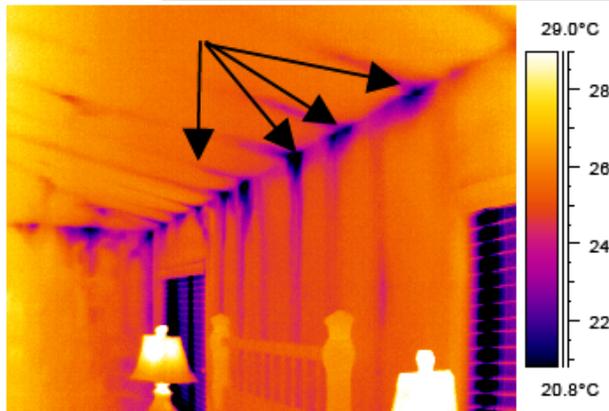
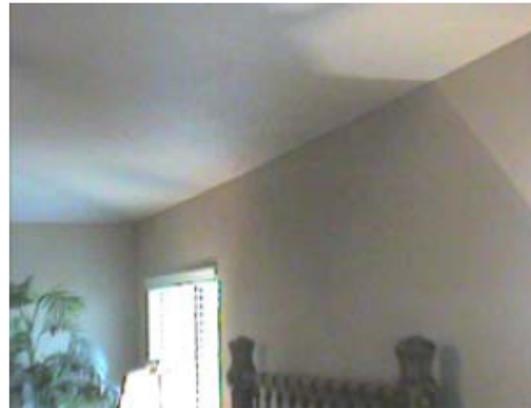
IR99 East wall/ceiling of master bedroom showing air infiltration  
**4. within the wall cavities**

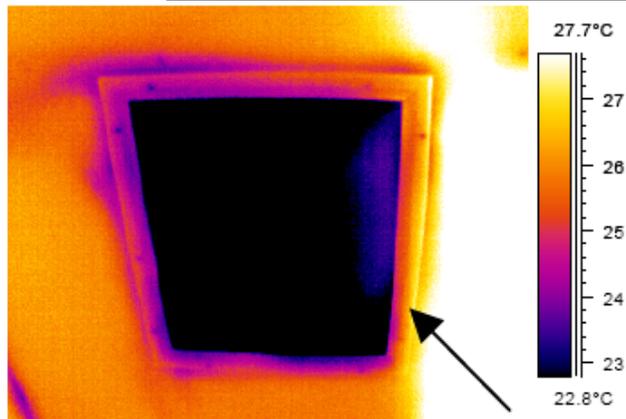
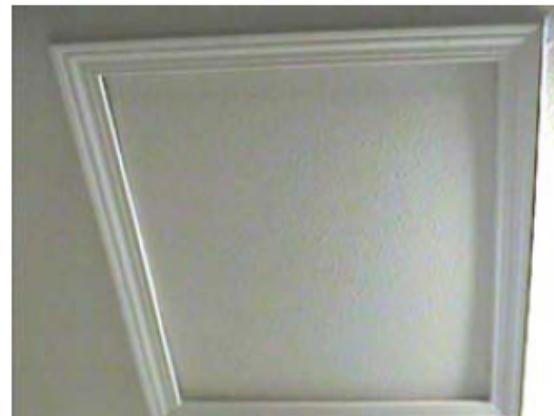
IR87 Attic access master closet showing lack of or improper  
**10. application of insulation (not attached or in contact with the drywall)**
