# THE EFFECTS OF ENERGY EFFICIENCY TREATMENTS ON HISTORIC WINDOWS

Project # 2008-M1-024

Grant Recipient: The Center for ReSource Conservation

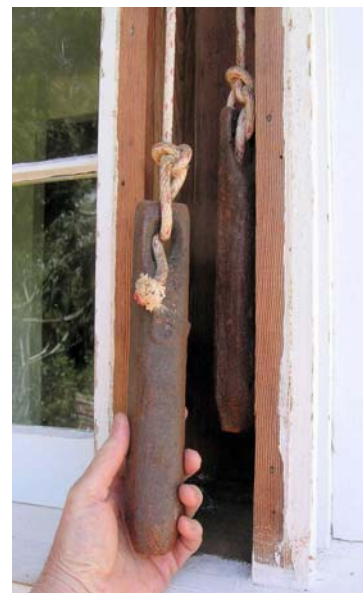
**Figure 2-2. Counterweights common to many historic window systems**

Unlike newer windows, older double-hung window systems routinely use counter weights to aid opening and closing the window. Counter weights are heavy solid iron castings attached to ropes that run through pulleys then attach to the edges of window frames. These weights slide up and down in uninsulated vertical boxes on each side of the window. The result is counter-balancing forces that aid in opening the windows and holding them open to the degree desired. The counter-weight boxes constitute a large portion of the fixed part of the window frames. A combination of visual inspection, blower door testing, and infrared scans reveal that these boxes are frequently the source of substantial convective and conductive energy losses in both summer and (especially) winter.

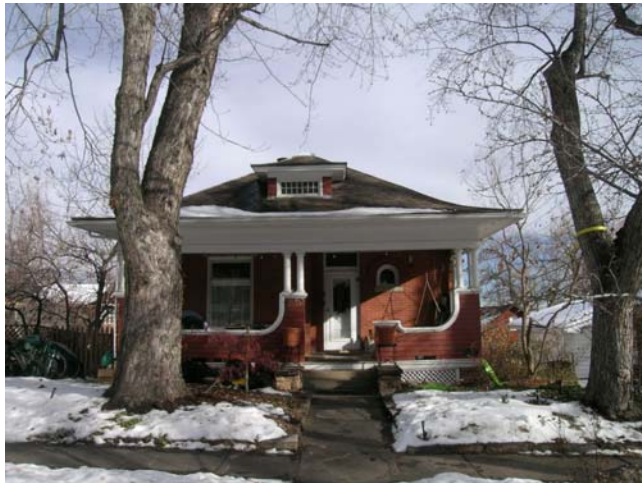
**Figure 2-3. West Elevation of Vintage 1902 Test Home**

before identifying an appropriate home for the study. It is a charming 2700 square foot brick home built in 1902. The home has many original single-glazed windows, most covered by triple-track aluminum storm windows. It is heated by a wood stove in a chimney plus a natural gas-fired boiler that provides hot water to conventional radiators. Since heating energy from the boiler is circulated through pipes, the only duct work of consequence provides supply air from a roof-mounted evaporative cooler that pushes cooled air through the home towards partially-open windows.

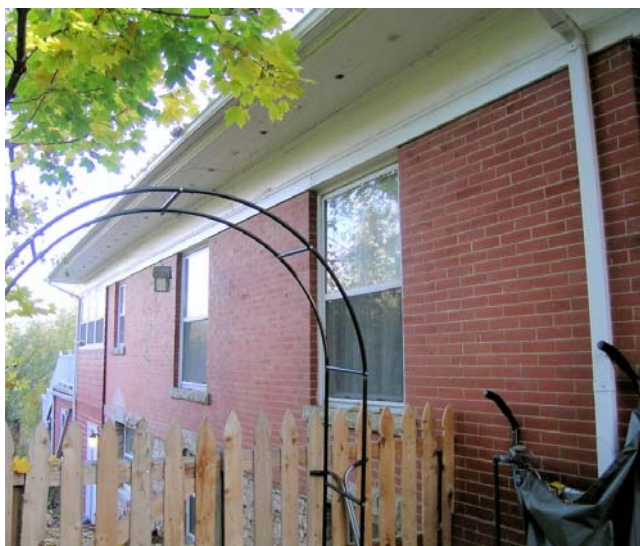
**Figure 2-4. Northwest Elevation (The closest 3 windows were chosen for retrofit)**

The study team identified three window systems on the north and three on the south of the home to be studied (see Figures 2-4 and 2-5). The three windows of interest on the south side of the home are each associated with single rooms. The team was able to largely isolate two of these from the rest of the dwelling for testing (the third cannot be fully isolated from a foyer in the front of the home).

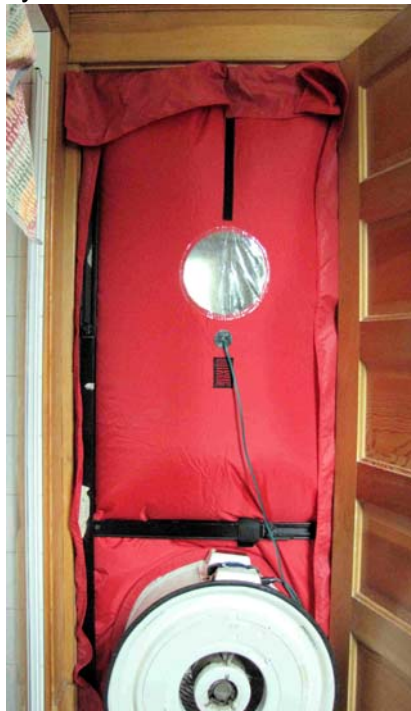
**Figure 2-6. Blower Door Installed in Bathroom Doorway**

After taking measurements for both SHGC and  $V_t$  to assess the performance of the windows systems, a blower door was set up in the doorways associated with each of the three windows

on the south side and the main doorways of the home were opened. The study team used a Model 3 Minneapolis Blower Door produced by the Energy Conservatory. This is the most widely-used instrument in the industry; tens of thousands are in use to assess the leakiness of buildings and measure the degree of success achieved in air sealing. In this project, the team took measurements of the whole house and in the three rooms housing the test windows before and after window retrofits were installed.

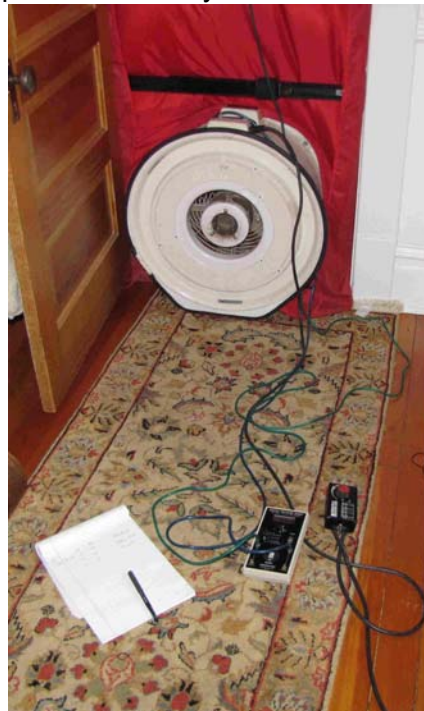
**Figure 2-7. Blower Door Installed in Bedroom**  
(Speed control on floor on right; digital manometer in center)

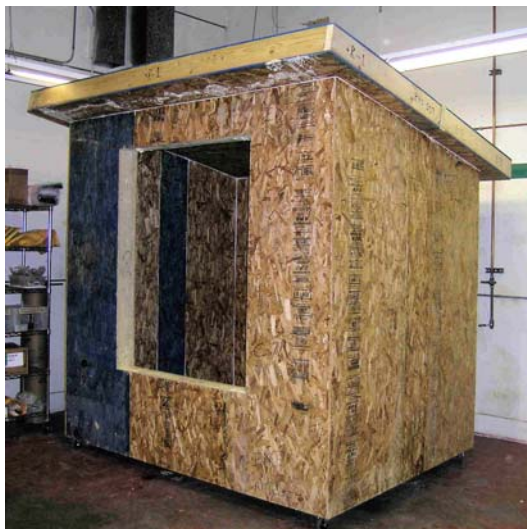
Figure 2-8. Test cell after first day of assembly

The study team designed and constructed a super-insulated, tightly-sealed 390 cubic foot test cell using six inch thick, urethane-based structurally insulated panels (SIPs) on all six sides. It is capable of testing window system samples of up to 20 cubic feet. The cell is heated with electric resistance radiant panels, controlled to maintain a constant warm temperature within a tenth of a degree F (e.g., 122°F). The test cell can be rolled into and out of a cold chamber built into the inside corner of a building. The cold chamber, which is insulated with 2 inches of polyisocyanurate and 3.5 inches of fiberglass (R-22), is accessed through a 280-pound door, weather sealed and insulated to R-25. The door opens and closes by means of a winch and pulley system suspended from steel roof rafters. The chamber is cooled by a modified room air conditioner to approximately 52F, thereby exposing fenestration samples to a temperature difference of 70 F. Figures 2-8 and 2-9 show the test cell and chamber during construction.

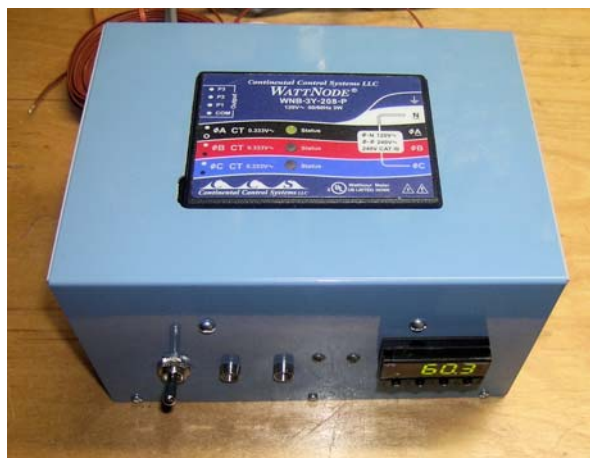
**Figure 2-10. Controller, top view**

The testing laboratory includes a controller designed and built by the project team (see Figure 2-10). The controller employs a WNB Series WattNode electric energy meter manufactured by Continental Control Systems, which produces pulses whose count per unit time is proportional to true watt hours used by the heaters in the chamber. It is calibrated to produce 53,333 pulses per kWh, 0.01875 watt hours per pulse. The electronics also measure temperature and control heaters in the test cell using an Omega Model CNi32 Temperature and Process Controller.

This industrial thermostat is used to operate a relay, which controls a pair of infrared heaters on either side of the test cell that can radiate up to 800 watts if needed, although a phase controller set at approximately 500 watts produces

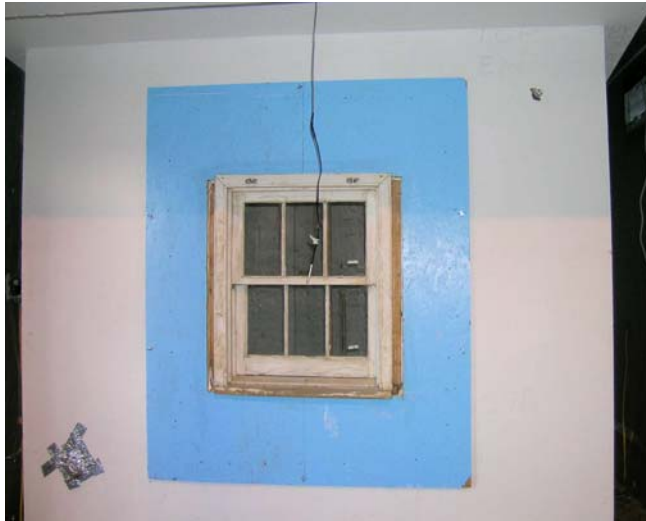
**Figure 2-11. Test cell configured to test small double hung window**

The chamber is calibrated with a given plug via three runs of 24 to 48 hours each, which results in the overall U-value of the chamber with the particular plug installed. (The difference between the U-value of one plug and another is typically less than one percent.) A given plug is then used to "house" window samples, beginning with smaller window samples if practical. Under this circumstance, the energy required to maintain the chamber at a given delta T is the sum of (1) the known U-value of the chamber times the area of the chamber minus that of the sample and (2) the unknown U-value of the window sample times its area. Thus determining the U-value of the sample involves measuring its area carefully and ensuring it is completely sealed to the plug, then making another chamber run to gather temperature and energy consumption information.

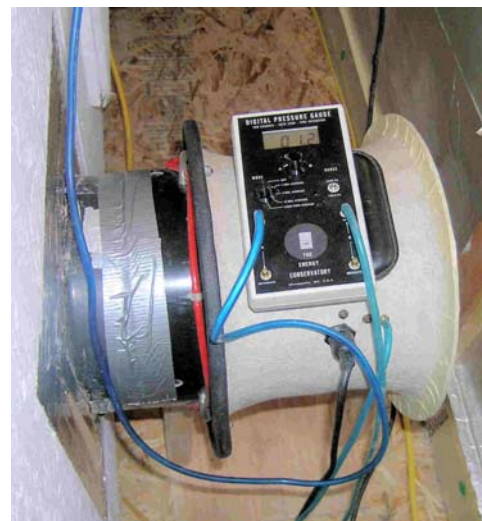
**Figure 2-12. Duct blaster with manometer**

The chamber was built to be extremely tight (see Appendix B), so leakage is very close to zero. The test cell has one access door (itself carefully weather-stripped and insulated to R-35) and the aforementioned 20 square foot opening for testing windows into which calibration plugs or plugs with sample windows are inserted. Two additional holes accommodate leakage testing (both of which are insulated with tight-fitting plugs of 7 inches of urethane and air sealed when not conducting leakage tests). Leakiness was measured using a custom-calibrated duct blaster and two digital pressure gauges from the Energy Conservatory. One 12 inch diameter hole accommodates the duct blaster and allows for precise leakage measurement. The other hole is used to introduce leakage air of a known area (3.14 square inches) via a 2 inch diameter hole. This allows the fan to operate in the "sweet area" of its calibration curve to maximize accuracy.

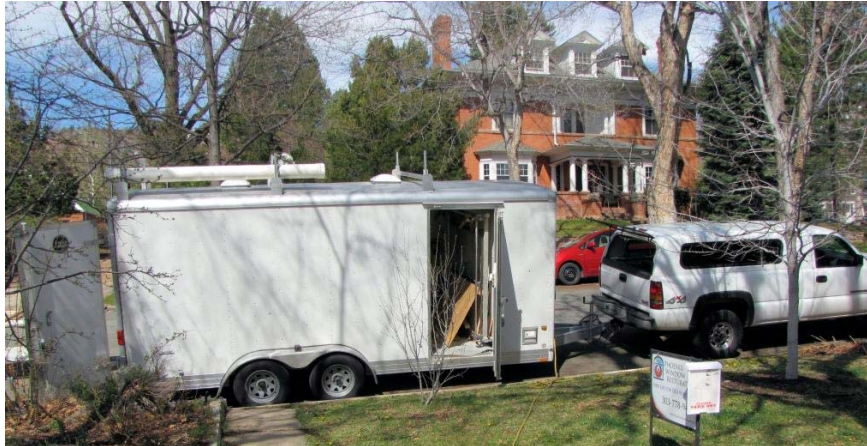
**Figure 3-2. Phoenix window’s fully-equipped portable shop**

Figure 3-2 shows the portable shop used by Phoenix for window retrofit work. Figures 3-3 through 3-7 show a sample of photos of retrofit work at the test home.

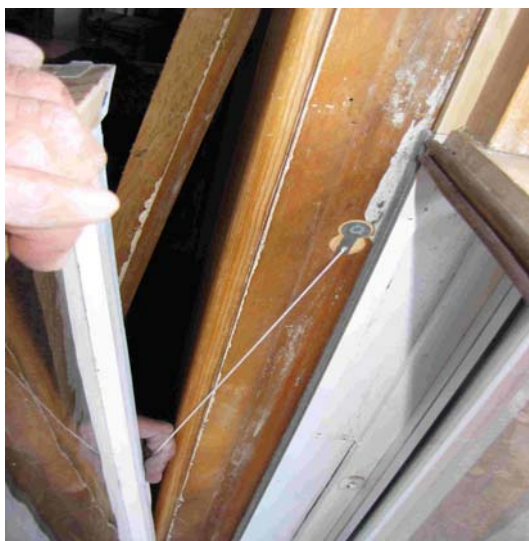
Figure 3-6. Installing spring

Windows 1 through 3 and 5 and 6 each had weights removed from their pockets, the pockets air sealed and insulated, and spring systems installed to retain window functionality and replace counterweights. In addition, all six windows were carefully rebuilt to the extent necessary. This included removing layers of old paint, filling holes and cracks, repriming and

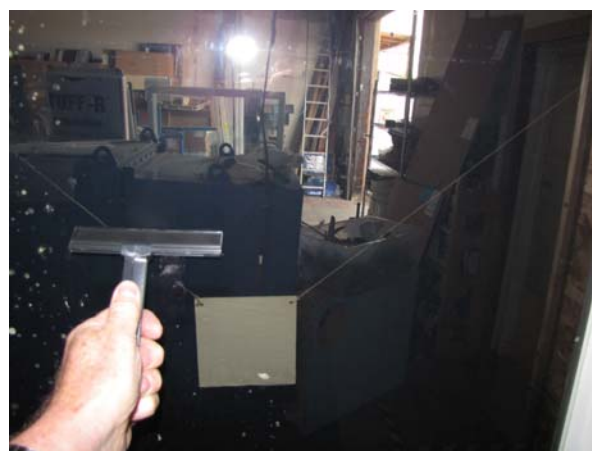
Figure 3-9. Energy Film installation

The team tested the heat transfer coefficient (U-value) of two types of Energy Film, a clear and a darker version, in relation to the U-value of a clear, single-glazed storm window. First, we installed the single-glazed storm window in the chamber with a wood frame. Its overall size is 15.89 SF and glazing area 12.93 SF, representing 81.4% of the window. We then ran a 24 hour test for U-value.

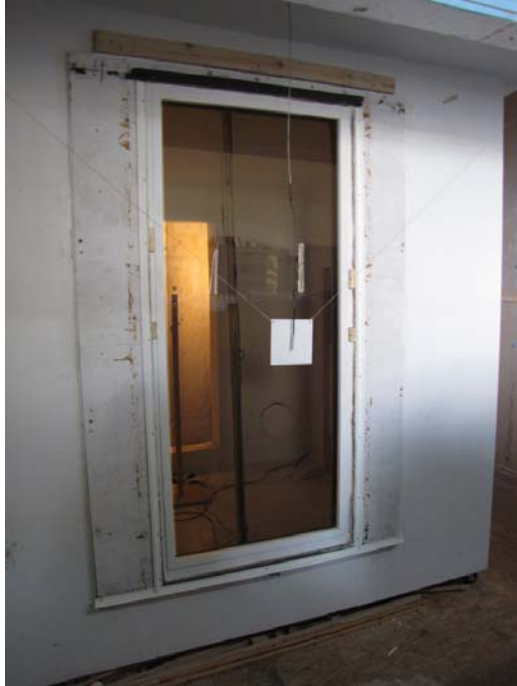
**Figure 3-10. View of window with dark film installed from outside the chamber.**

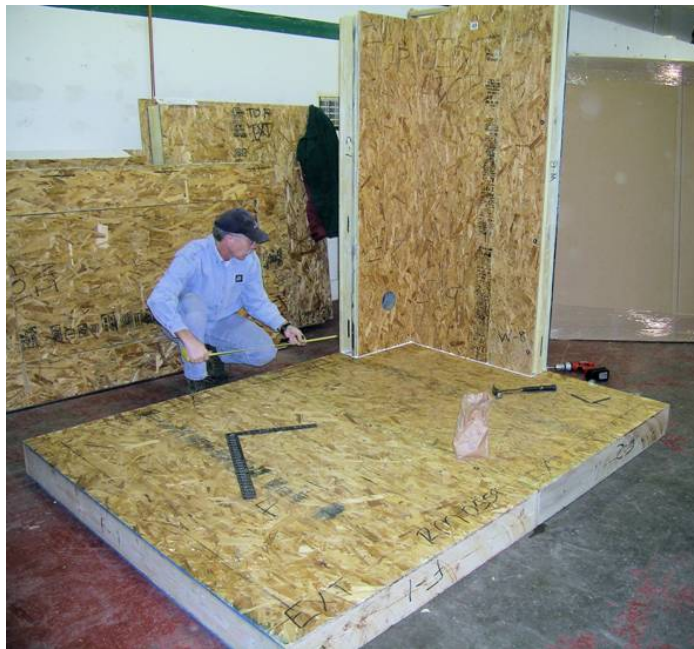
The test cell was constructed using structural insulated panels composed of oriented strand board on either side of urethane insulation. The photo on the left shows the first corner of the test cell being set into place.

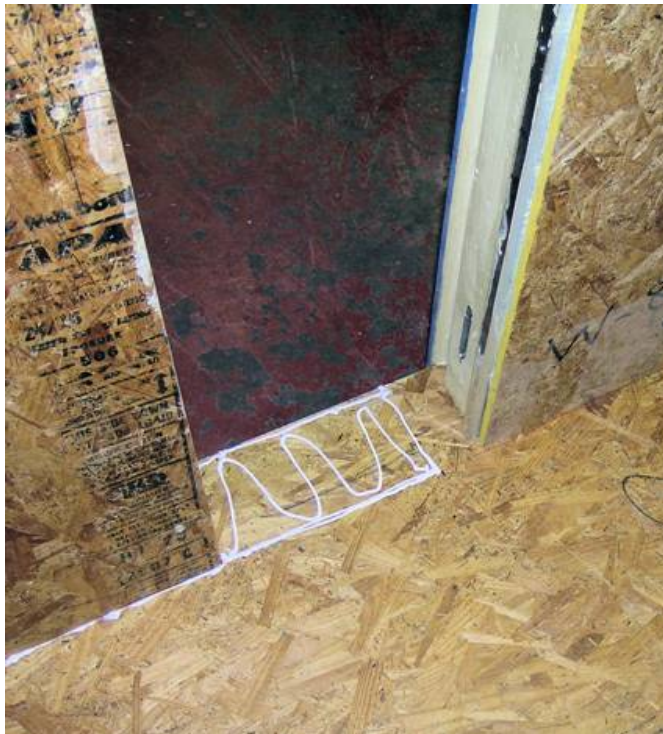
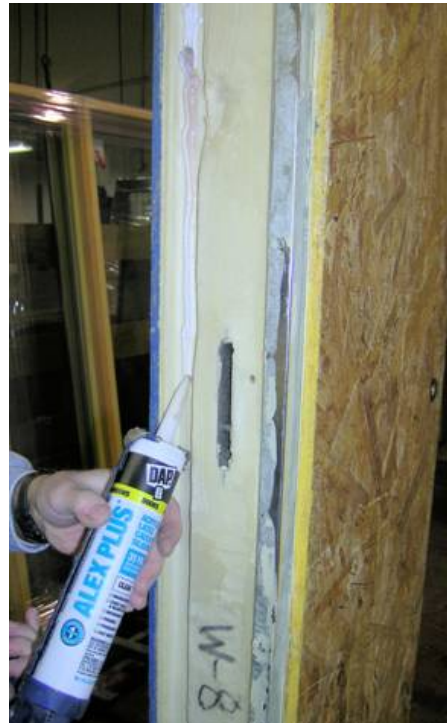
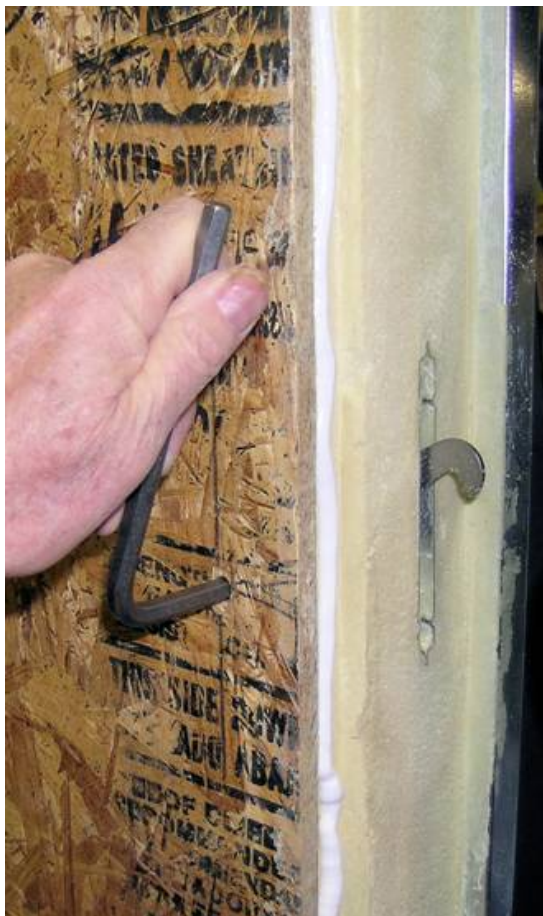
Each joint was sealed using urethane foam insulation and caulk to ensure joints were well sealed. The team used clamp hooks to snug the walls together. Then, wheels were installed to roll the test cell in and out of the chamber. The photo below shows the constructed test cell following a day's work.

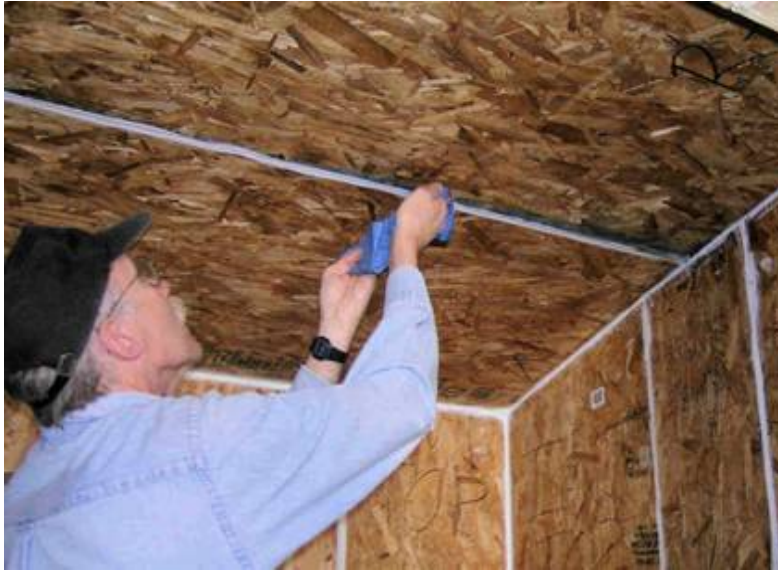
Fourteen tubes of caulk were applied to the post-assembly test cell. Three coats of vapor barrier paint were then applied inside and out to ensure well-sealed construction.

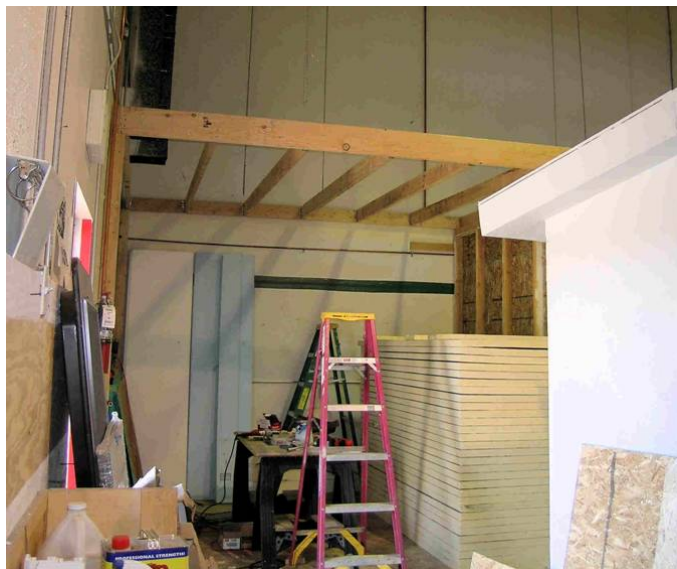
The chamber was framed into the corner of a warehouse. The existing walls were first covered in two inches of polyisocyanurate (R-13).

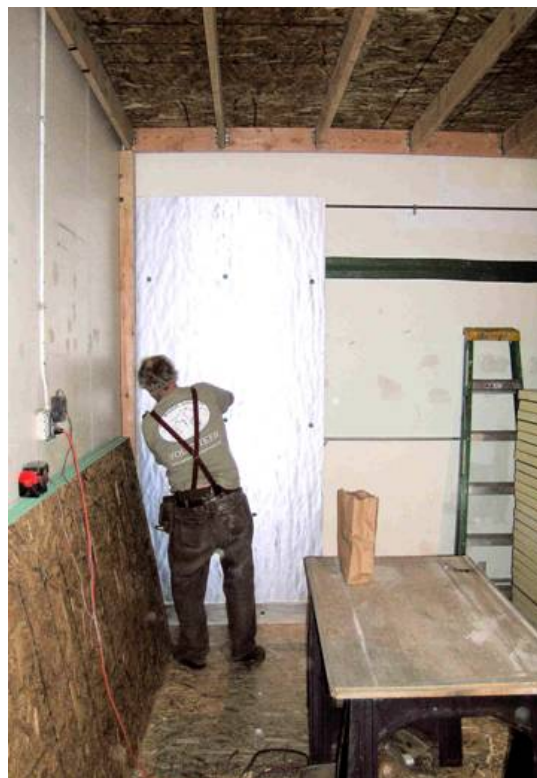
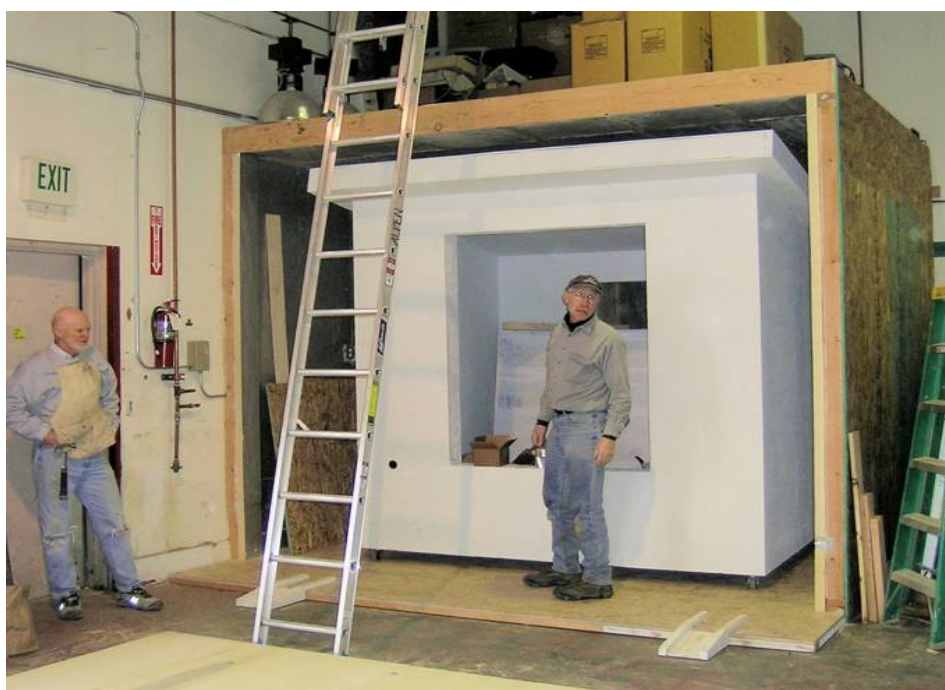
The photo on the left shows three walls of the chamber completed with the test cell inside. The outer chamber, likewise well insulated and sealed, is cooled while the test cell is heated to test U values.

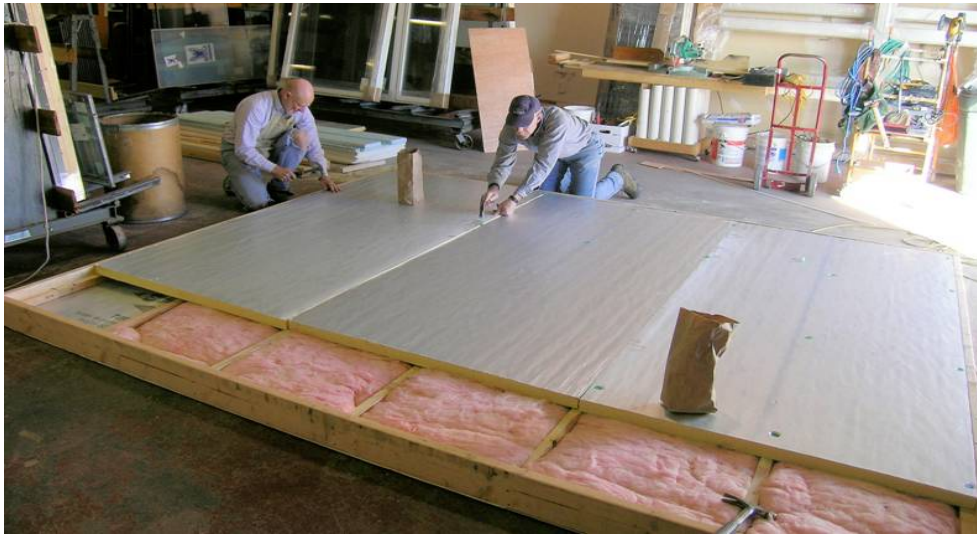
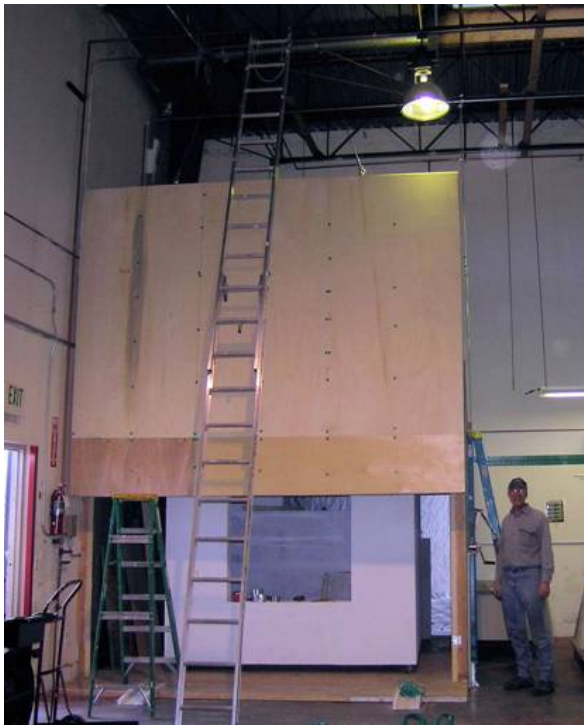
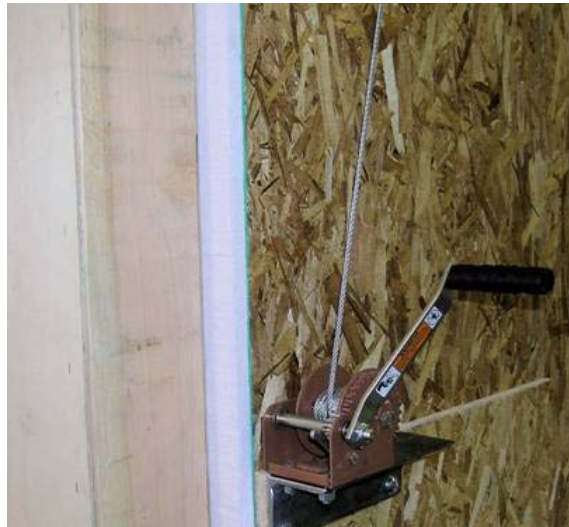
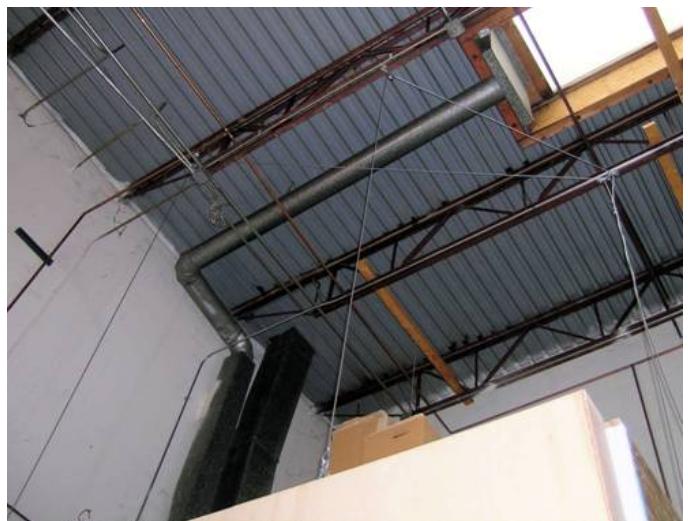
The technical team constructed a 380 pound door (see photo at left), insulated with both fiberglass and polyisocyanurate to R-25. The photos below show a winch and pulley system, suspended from steel roof rafters, used to open and close the chamber door.

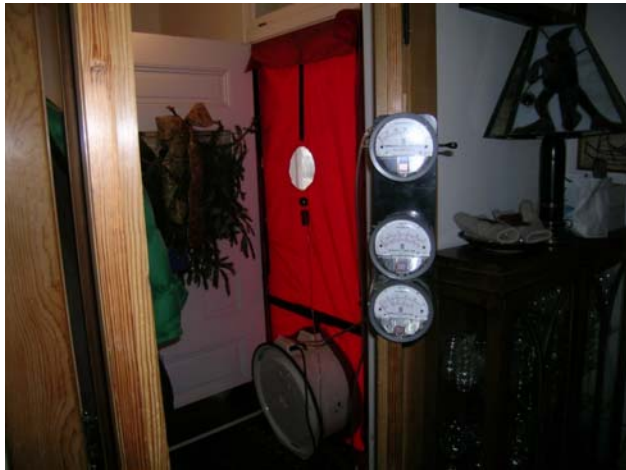
Blower door test

The two-story 2700 square foot home is quite leaky; the blower door reading showed 3500 cfm of leakage when the conditioned envelope was depressurized to 50 pascals of pressure. (Between the audit and the retrofit of the home, the homeowners undertook a number of air sealing measures—none of which had to do with windows—which resulted in lowering the blower door reading to 3000 cfm at 50 pascals. As reported in Section 3, the window work resulted in bringing the leakage down to 2860 cfm at 50 pascals.)

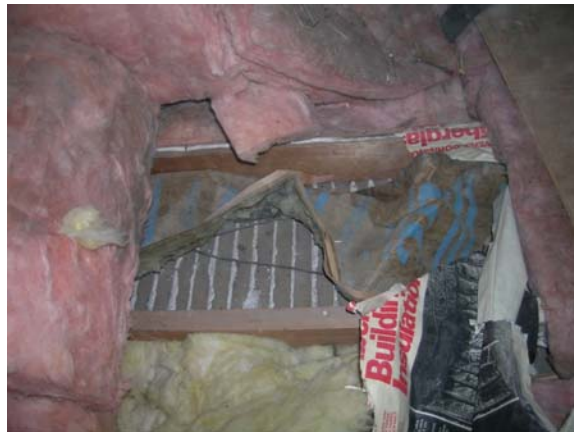
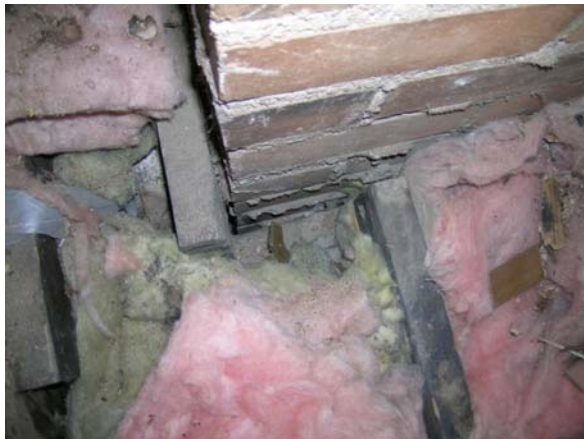
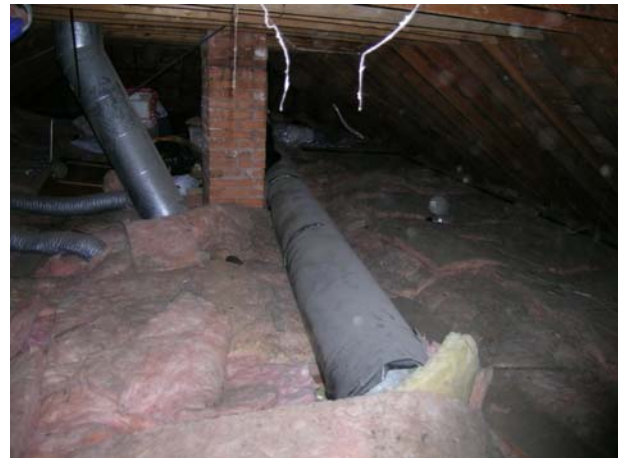
In spite of spotty insulation in the attic (see photos at left and below) and none in the walls of the old portion of the home (there's a newer addition on the back—east—façade of the home), air leakage accounts for approximately half of the heating load on the home. Such leakage causes energy waste and discomfort, and can shorten the lifetime of beautiful old homes like this one.

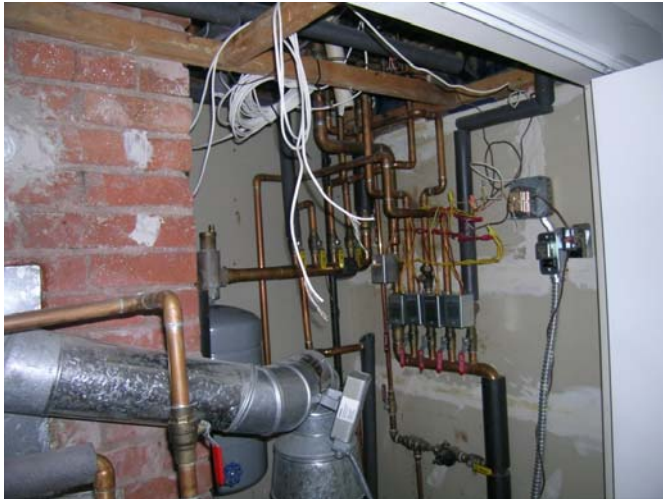
Multi-zone heating system

The home is heated by a multi-zoned, gas-fired boiler expertly installed by the homeowner. One zone, controlled by an aquastat, heats water in a “side arm” tank which supplies the home’s needs for domestic hot water.

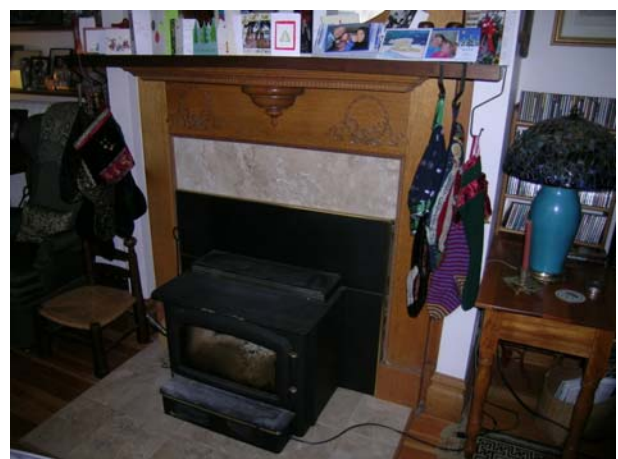
In addition, a good deal of the heating load is met by a wood-burning stove mounted in front of a chimney centrally located in the home’s living room. The modest cooling load is met by an evaporative cooler on the roof. Of consequence to the window retrofit, distribution of cool air from the evaporative cooler involves opening a number of windows to direct cool air to spaces that need it.

Wood stove vents into existing chimney

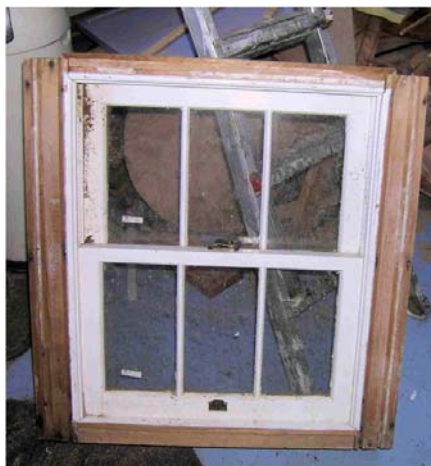
Unlike newer windows, older double-hung window systems routinely include un-insulated boxes on their sides that contain iron weights, ropes, and pulleys. The ropes connect weights to the frames of moveable lites of the window systems, thereby providing counter-balancing forces that aid in opening the windows. Such boxes constitute a large portion of the fixed part of the window frames. A combination of visual inspection, blower door testing, and infrared scanning reveal that these boxes are frequently the source of substantial convective and conductive energy losses in summer and (especially) winter. Thus, the combination of large cross sectional area and thermal leakiness of the frame means that even if glazing is replaced with excellent insulating glass, the overall performance of the window system is doomed to be modest at best.

Old window with closed counter weight pockets

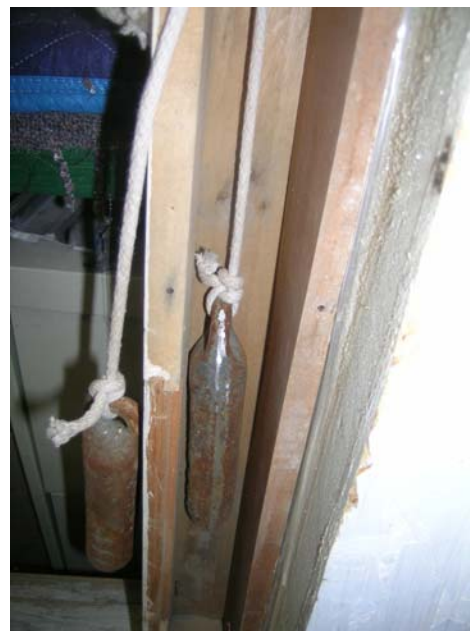
Ropes connected to these weights pass over pulleys and down the inside edge of the window frame and sash. The sash is usually equipped with a hole drilled in

Open pocket with counter weight

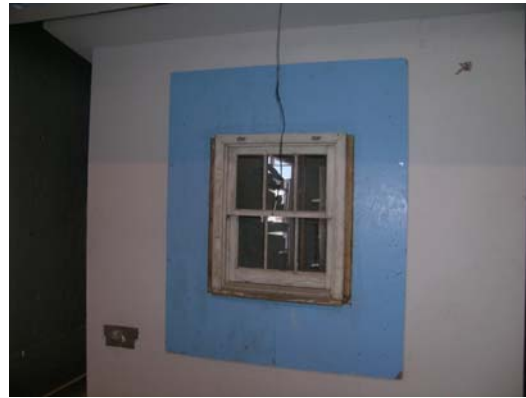
First, we tested the window “as is” in the test chamber. A 4 x 5 foot insulated plug was adapted to fit the window. The plug was fitted in the chamber and tested for air leakiness, then U value.

Window in the test chamber

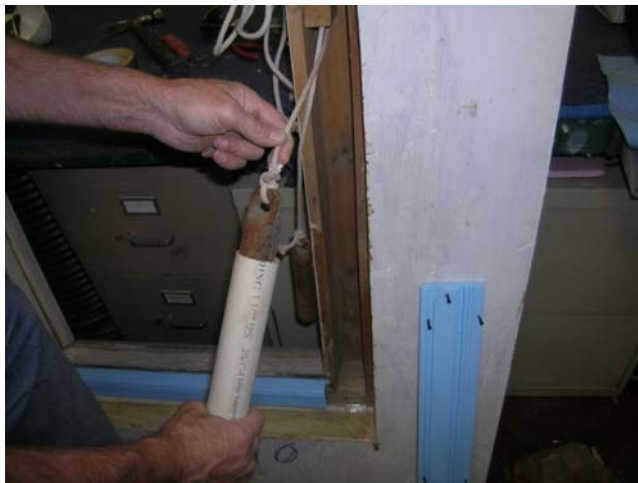
Inserting a plastic pipe, whose inside diameter is just larger than the outside diameter of a counter weight is the key to the solution. The weight slides inside the pipe while the rest of the open space in the counter weight box is sealed with expanding foam insulation such as urethane.

Sliding counter weight into PVC tube

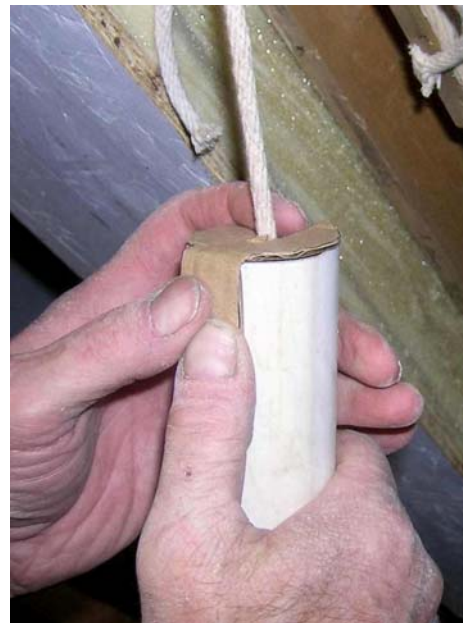
New weight ropes are installed and cardboard and packing tape is used to seal up both ends of the PVC tubes to prevent urethane from penetrating the area where the weight slides.

Cardboard in place over PVC tube

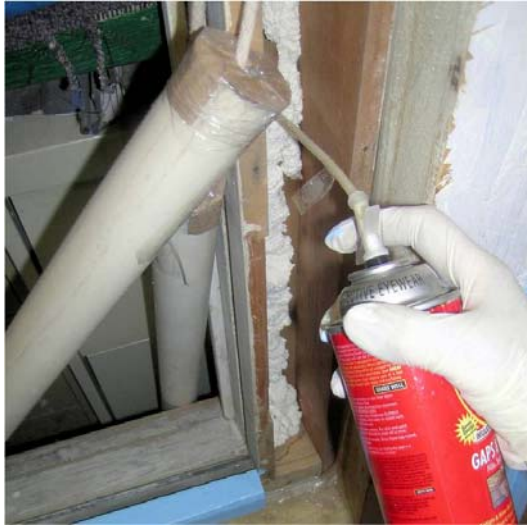
Adding urethane to pocket

Urethane is applied in layers to ensure weight tubes are completely surrounded – foam (shown), 1<sup>st</sup> tube inserted, foam, second tube, and still more foam. Foam expands several fold while curing.

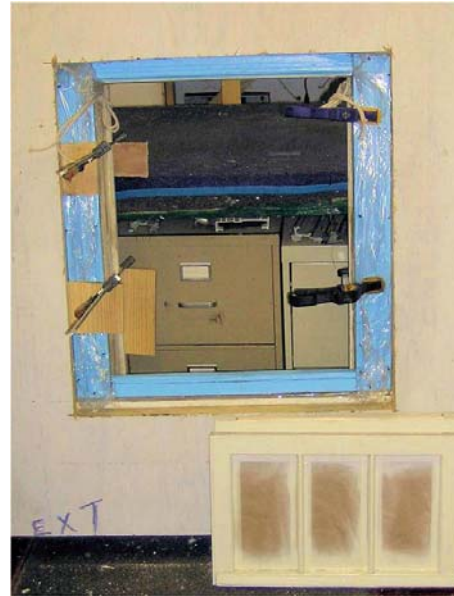
Everything in place to cure.
